From Leo Bellantoni

- 1) You have a list of findings from Steve Chappa
- 2) Likewise Karen Kephart
- 3) and from Jim Priest, a single additional finding.

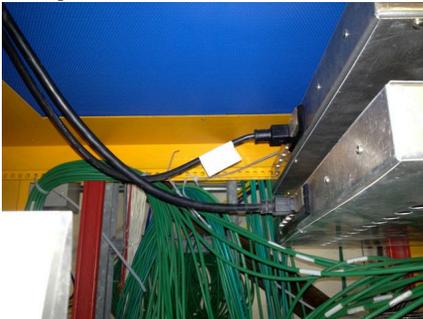
2. The power cords for the two scaler chassis, located within the Long Bo Counter rack, need to be strain relieved so that the weight of the cord does not pull on and stress the connector contacts.

The power cords are strain-relieved.

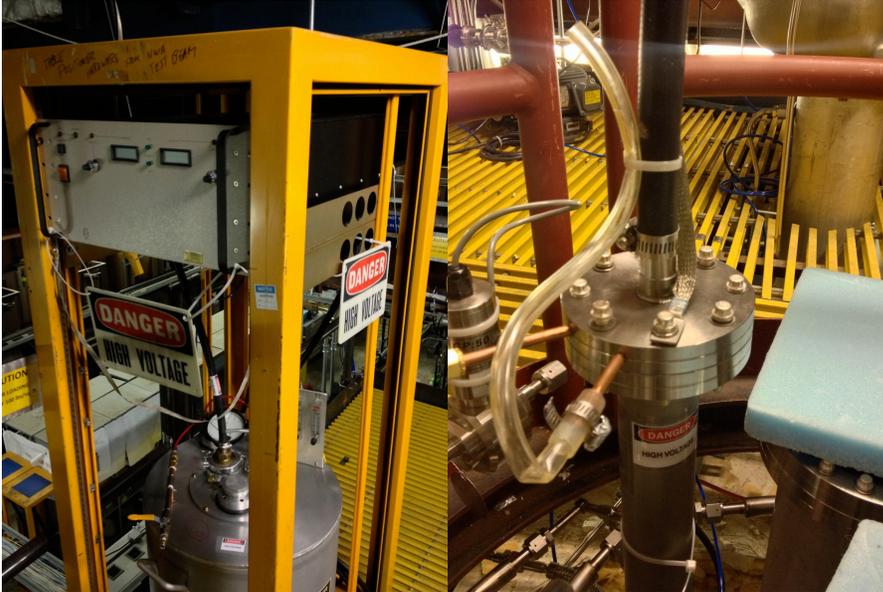
3. HV danger signs need to be located on the HV rack up on the upper platform. In addition, HV Danger labels need to be attached to the black HV cable.

HV signage has been posted.

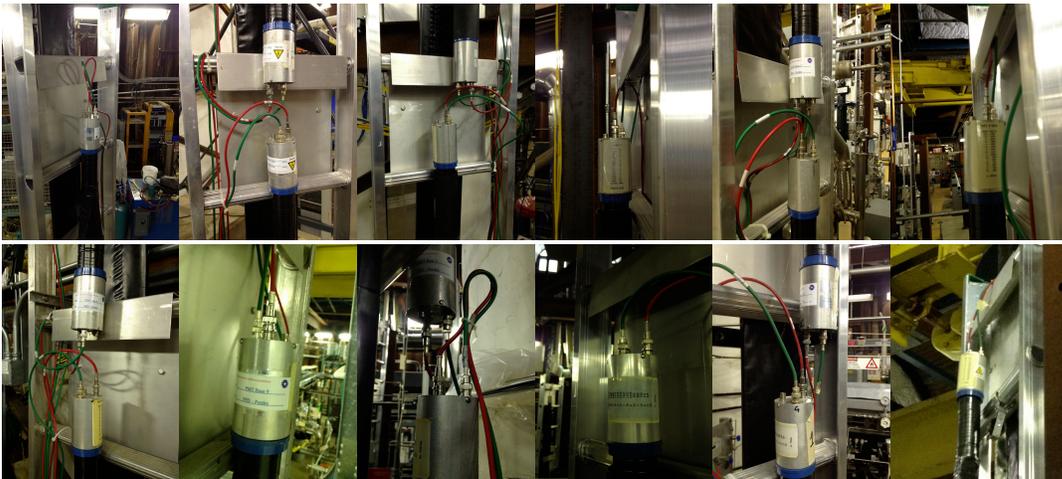
4. The HV and signal RG58 cables connected to the large PMTs need to be checked for proper strain relief to prevent damage to the cables' shield crimp connection.

Scintillation counters need to have all the signal and HV cables going to PMT bases checked and appropriately strain-relieved.

All the cables are strain-relieved.

All the cables are strain-relieved, please see picture on page 2.

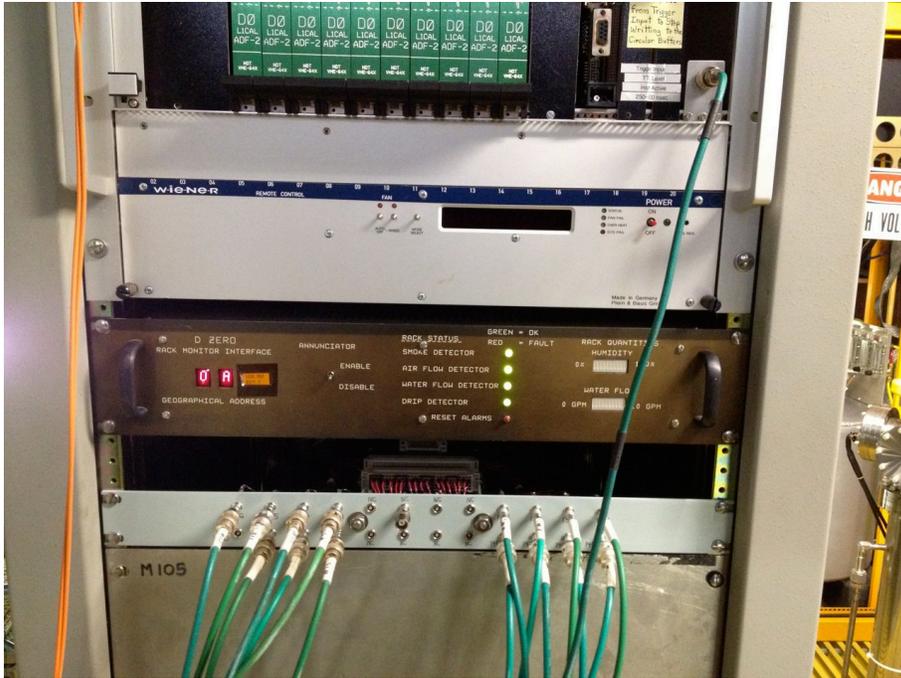
The TPC electronics rack located on the catwalk at the top of the vessel needs to have rack protection provided of the type that includes (at a minimum) a smoke detector wired to turn off power to the rack in case of an alarm.

Rack protection is installed and tested to be functional.

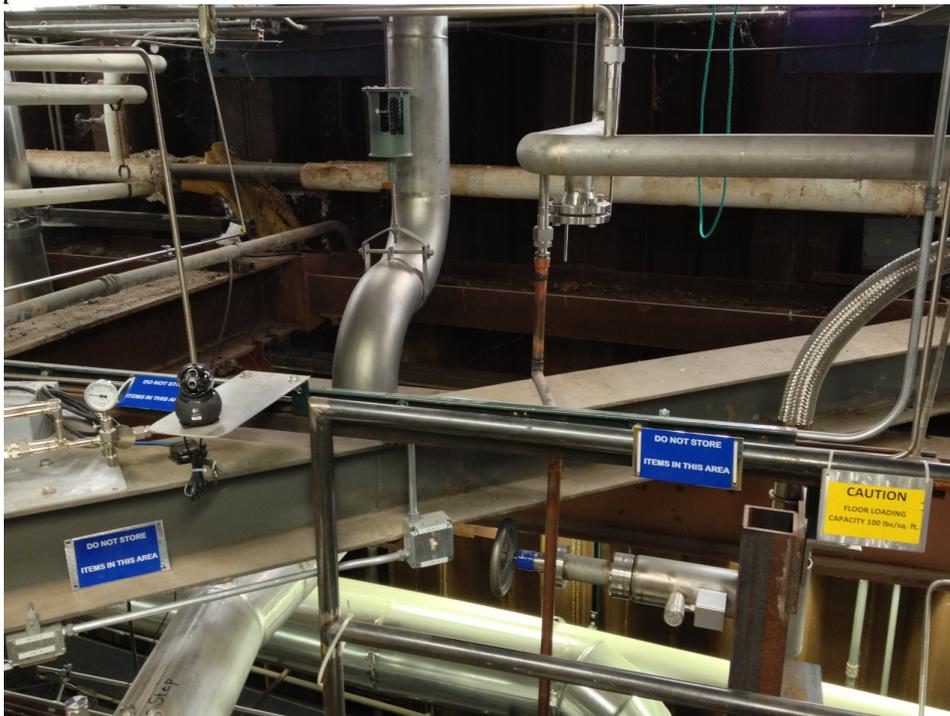
Open areas of the catwalk should have toe panels provided to that equipment cannot roll off onto personnel passing below.

The panels have been removed and do not store items in this area signs have been posted.

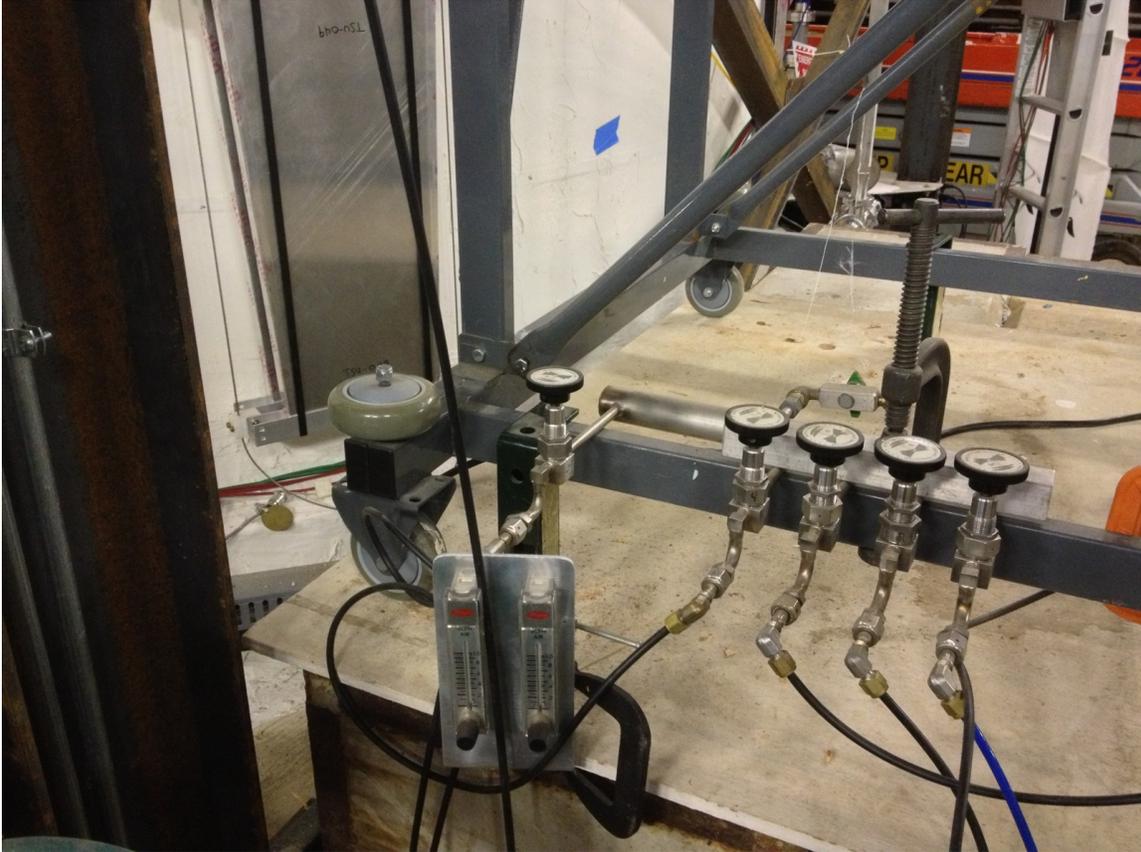
The plywood under the ladder should be repositioned.

The plywood has been repositioned.
