TPC update

Cinco de Mayo 2015

Dean Shooltz, Carl Bromberg

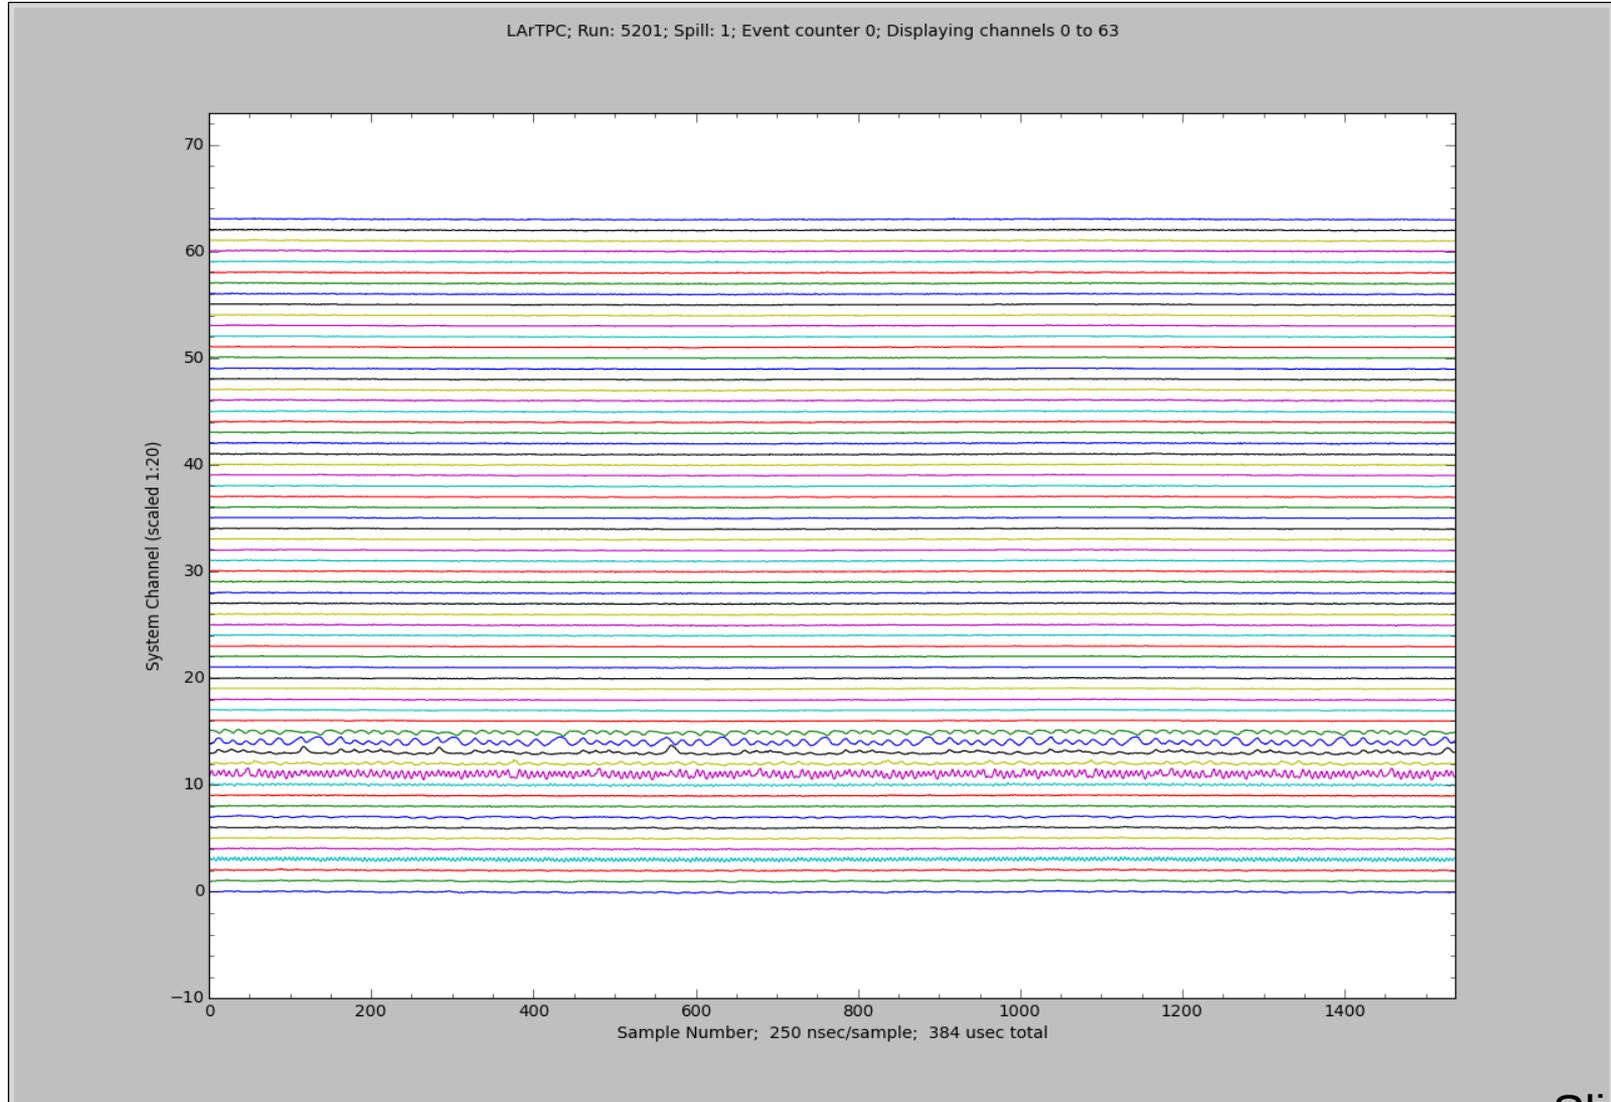
- Elog 2441 CAEN traces from 480 wires look good
- Elog 2442 Bias voltage is turned on
- Elog 2444 New noise signal is discovered (look at traces 0-15):

Event view of many ASICs with the strange baseline noise problem

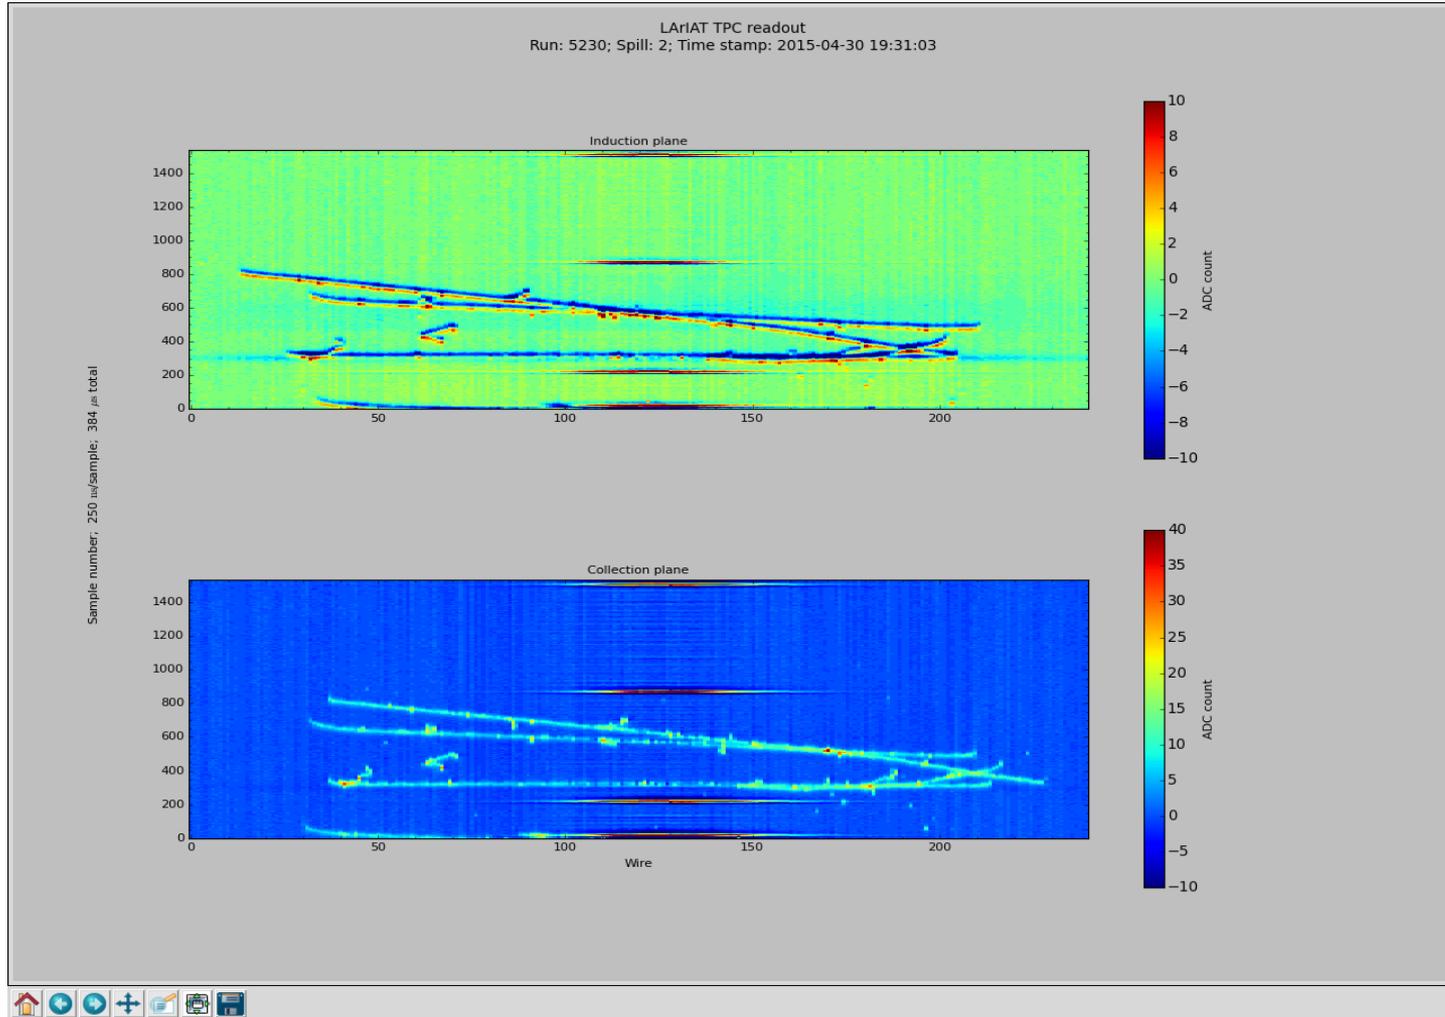
Elog 2500 – just after ASICs power cycle

The power cycle seems to have fixed the ASIC problem

Only solution found thus far: power cycle the ASICs.

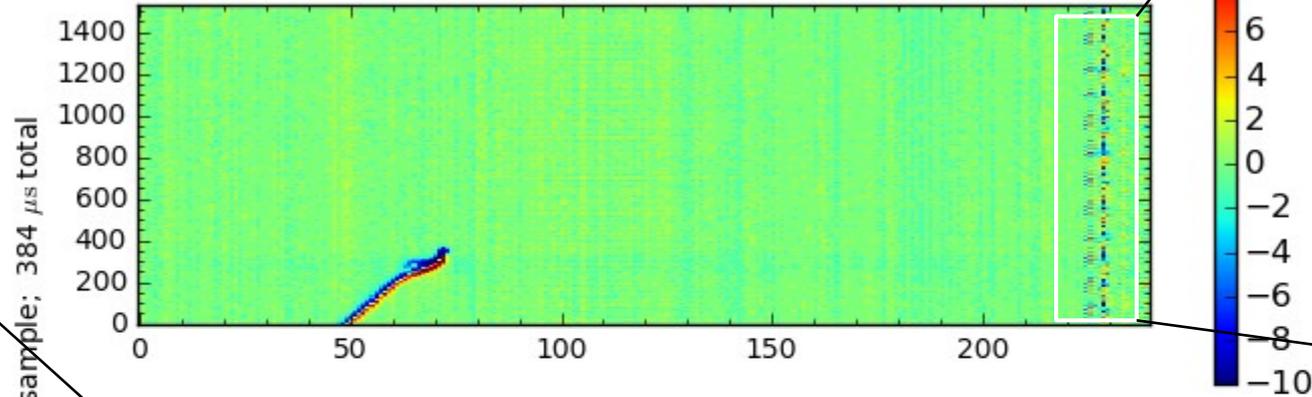
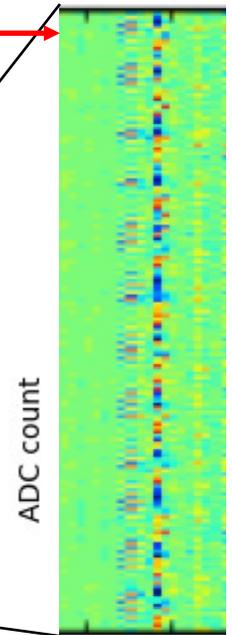
Induction plane

Better shielding needed

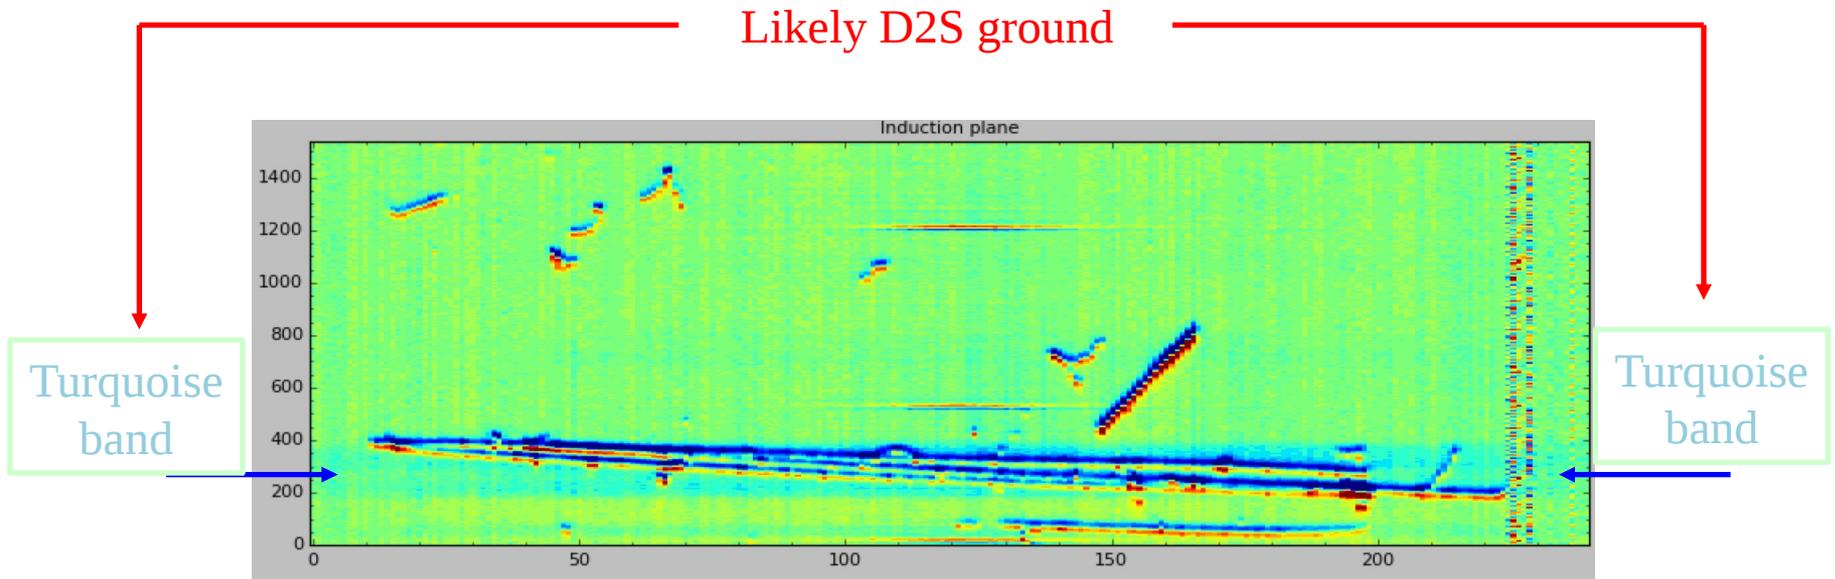
The Turquoise band seems to correspond to a crosstalk (ground bounce) in the D2S – to – CAEN connection.

We can stiffen the ground between D2S and CAEN with a modification of the D2S

Labor estimate: about one full day to extract D2S cards, solder, re-install.
