PMT Feedthrough tests

Motivation: One of the 5pin high voltage FTs for PMTs for LArIAT cracked during the UC light tests in April. Putting the others through stress tests to ensure they will hold up.

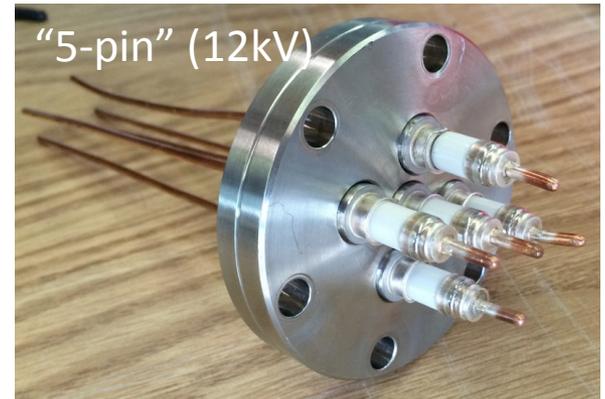
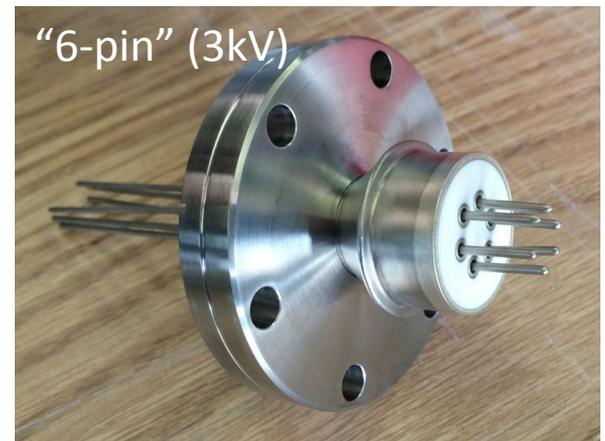
FTs to be tested:
two 5-pins
one 6-pin

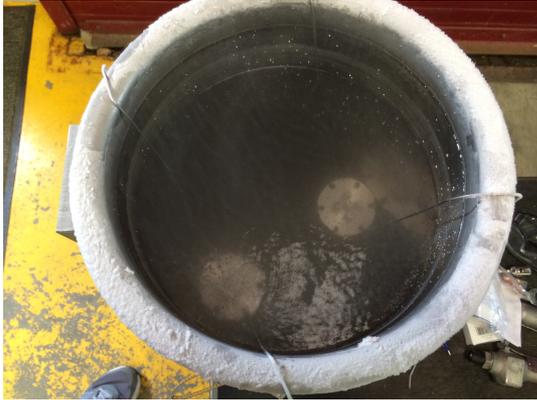
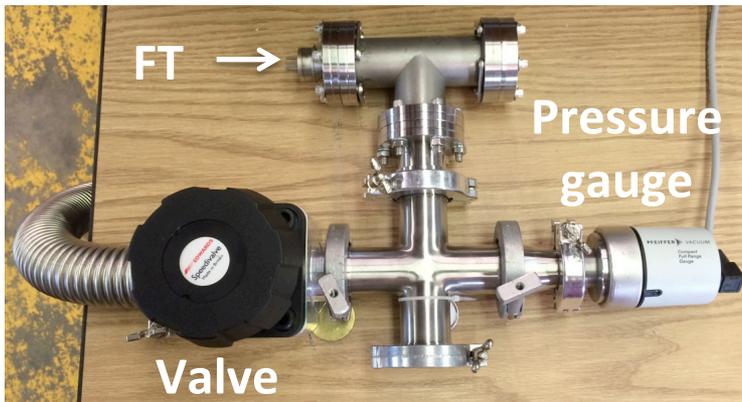
1. FTs dipped in liquid nitrogen 5 times (10 min each) as a cold shock stress test
2. Each FT vacuum-tested
 - Small chamber evacuated
 - Valve is then closed and rise-time from 2×10^{-2} to 3×10^{-2} mbar measured as performance metric (“leak rate”)

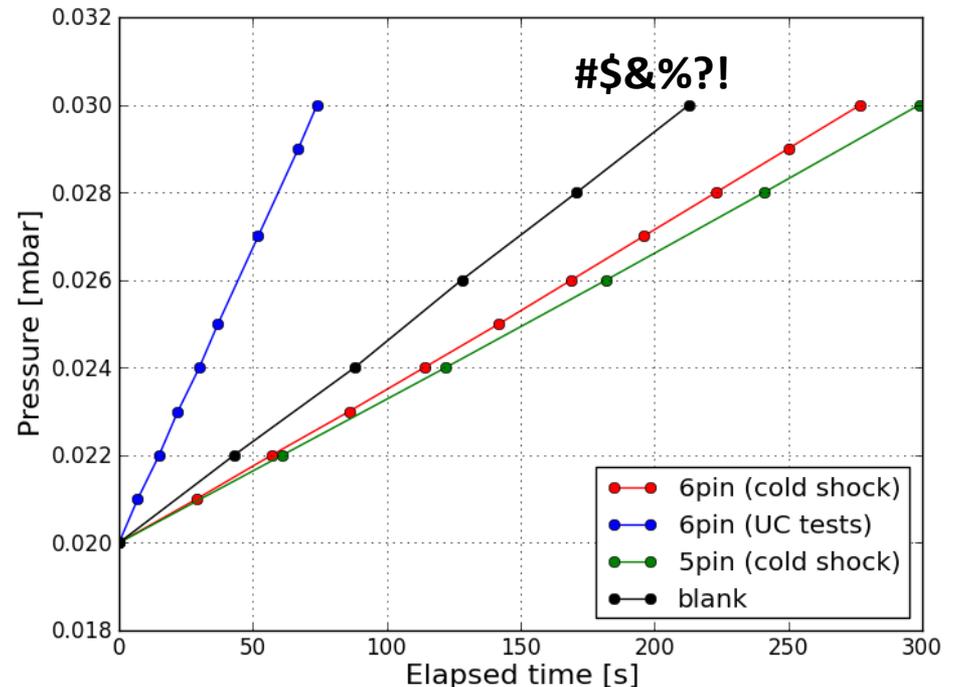
- One of the other 5-pins cracked again!! (just 1 lead this time)
- Remaining **5pin** and **6pin** that survived the cold shocks performed similarly
- **6pin from week-long UC tests** performed *poorly*
- **Blank** held vacuum worse than FTs... something else appears to have started leaking by this point (need to go back and resolve this, and then repeat tests)
