## Detector Test Report

Customer: Fermilab

**Detector QA Test**
**Model: 510-20x20-9/301**
**S/N: 3205-02-01**
**December 2, 2011**

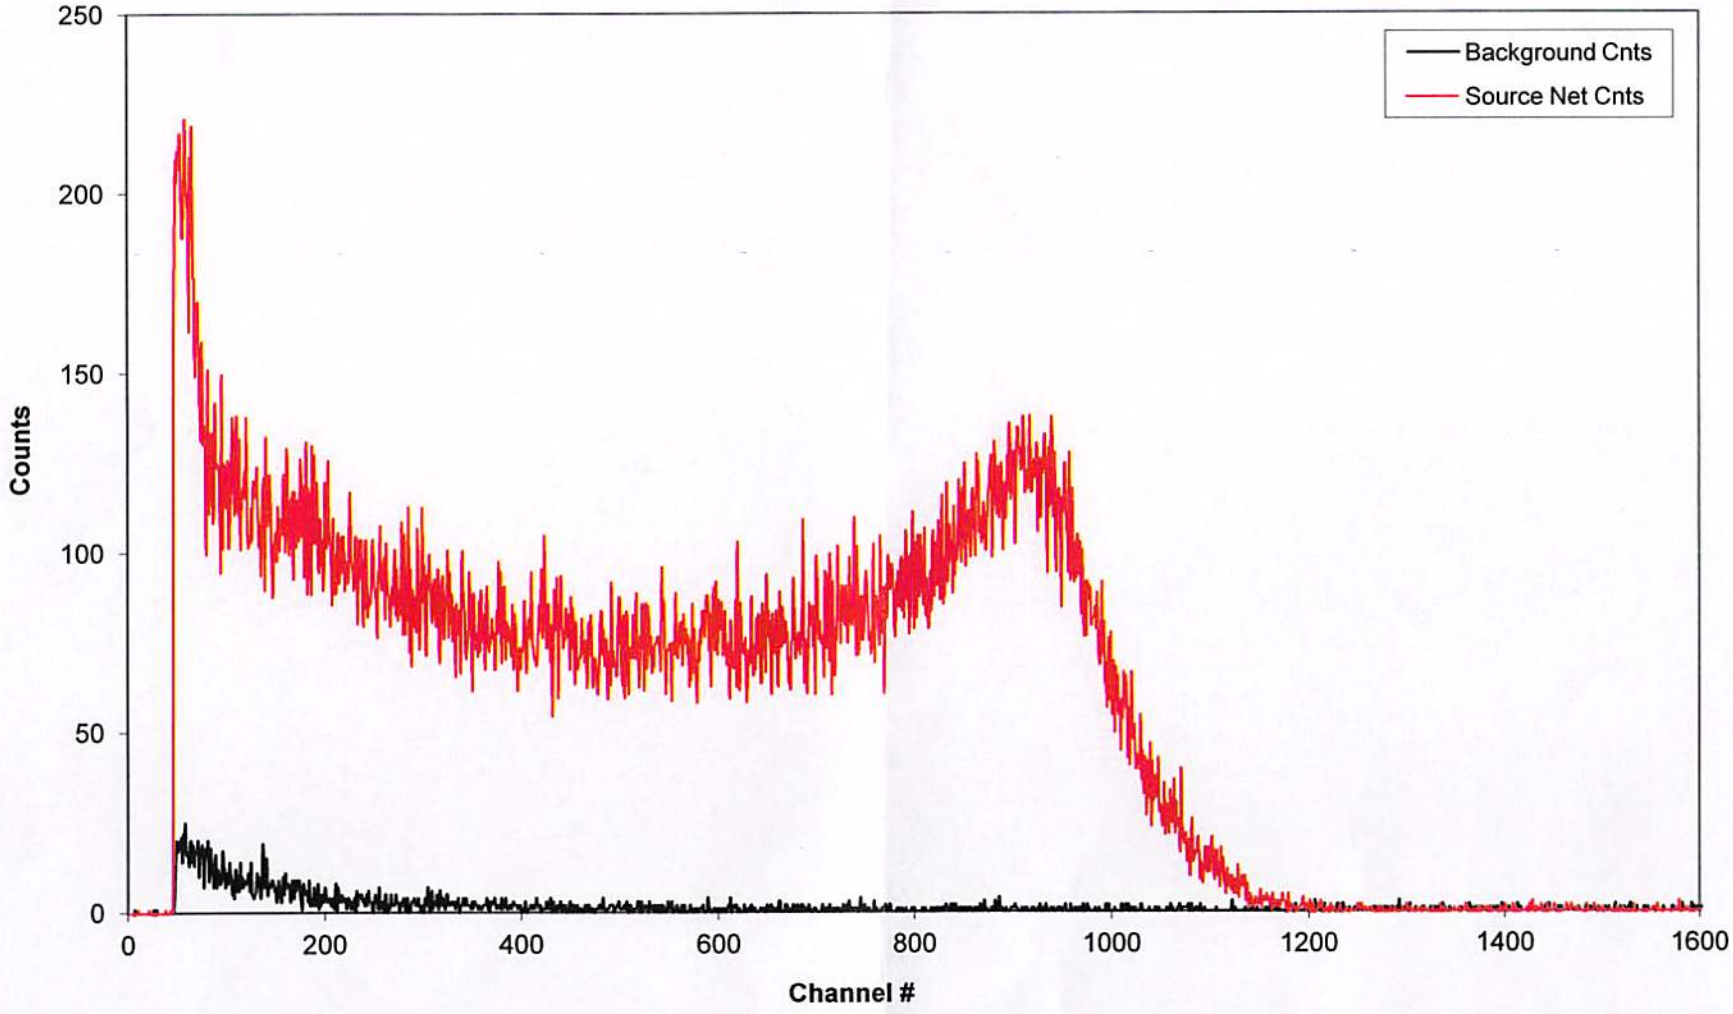
Unit is determined to be light-tight at the above operating voltage

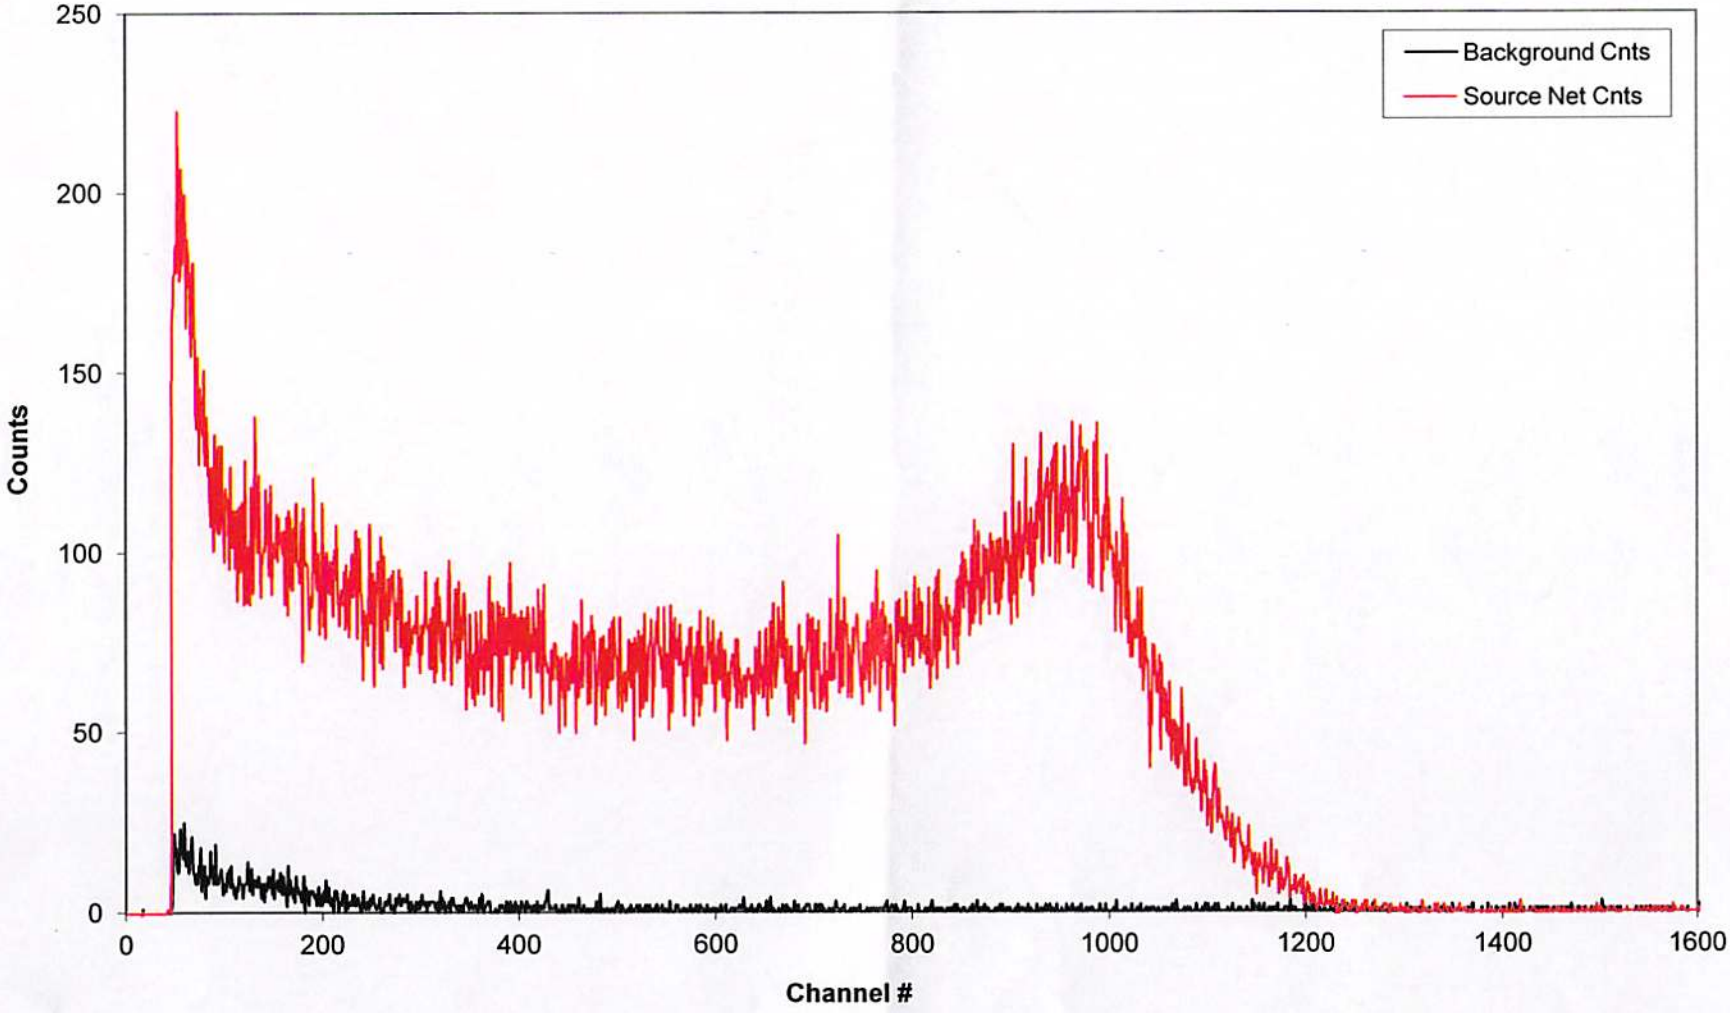
**Detector QA Test**
**Model: 510-20x20-9/301**
**S/N: 3205-02-02**
**December 2, 2011**

Unit is determined to be light-tight at the above operating voltage
